English Heritage Level 4 Building Survey

Rail and River, Night and Day 1/2/2012

Grantham Coates Surveys

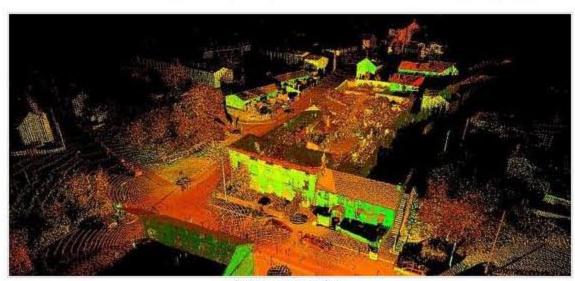
Laser scan overview

This week we have carried out a laser scan of a range of buildings in Mid Wales as part of a archaeological Level 4 building survey (English Heritage 2006). Deliverables to include, site layout, building elevations and sections as well as point cloud data. Please see below preliminary data prior to attaching hi-res true RGB photography.

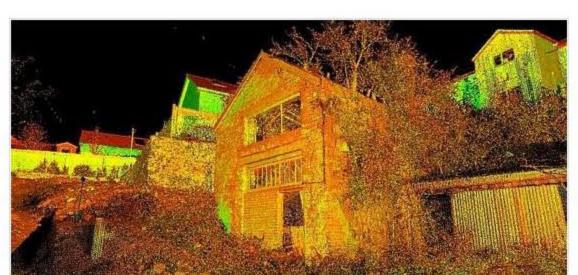
Laser scan for archaeological Level 4 building survey (English Heritage 2006)

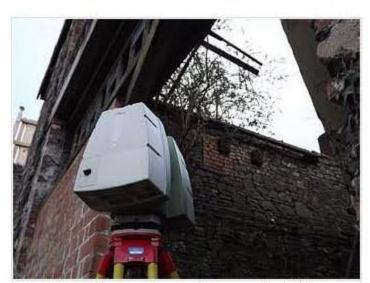
Leica C10 laser scanner used to survey the buildings

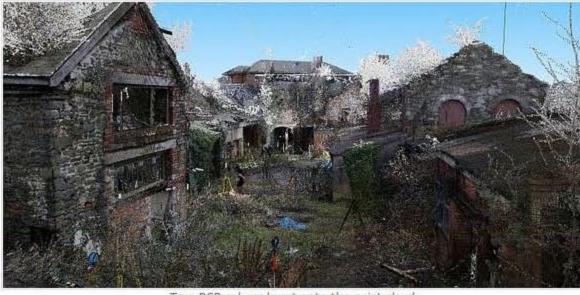
True RGB colours burnt onto the point cloud

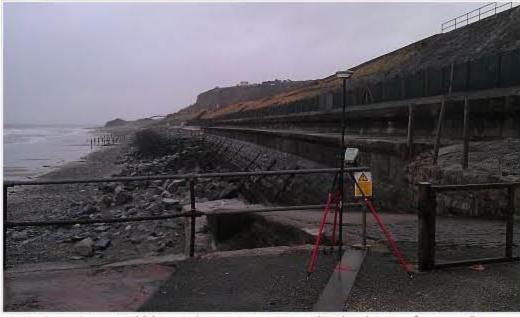
Leica Smart Rover establishing Ordnance Survey National Grid and Datum for sea wall survey

As well as the archaeological survey we are also carrying out survey work along a sea wall in North Wales. The project is to enable the design of sea defences to an existing wall with railway embankment above.

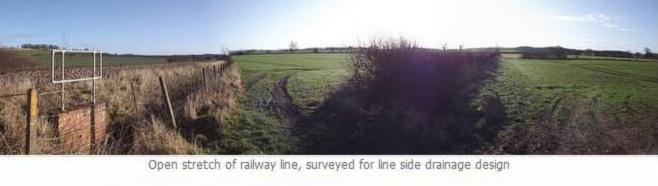
on Friday with a 6 hour night time possession on a short stretch of railway track for line side drainage design works. Followed by a couple of days on the railway north of York, again for drainage design, and finishing at the end of the week with a water course scour protection survey south of Todmorden.

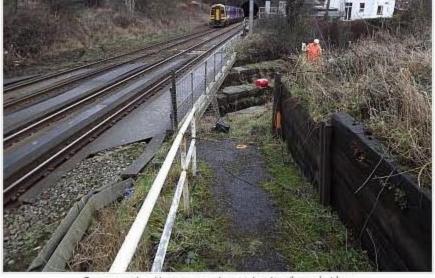
Scour protection survey to protect railway bridge
